Study of the Ways and Methods of Searching Water Leaks in Water Supply Networks of the Settlements of Ukraine

The problem of search of accidental and unauthorized water leaks in water supply networks is considered. The analysis of the current state of water supply sector in Ukraine based on information data of the Ministry of Regional Development, Construction and Housing Communal Services of Ukraine and data of the State Statistics Service of Ukraine is conducted. Existing methods of finding and determining places of water leakage in water supply networks are considered. The findings of the comparative analysis of the practical capabilities of search devices are reported. The primary causes and rates of water losses of the settlements of Ukraine have been determined. The results of the leakage search using device APGK-015/2, the calculations of the volume of water losses and the total cost of the water saved during the study are represented.

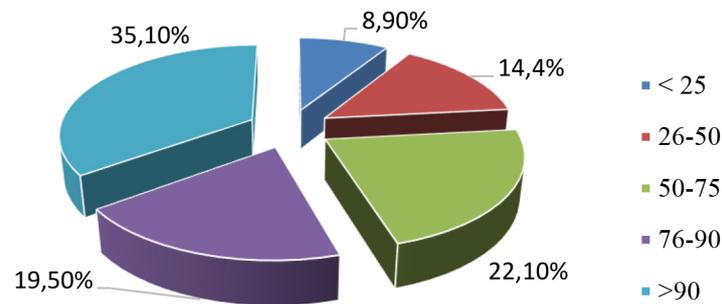
Figure 1. Water supply network length on the deterioration rate, %

In Ukraine, the most pipes are cast-iron (48.8%) and steel (44.8%). The least in number are asbestos cement pipes (1.9%). New plastic pipes are 3.4% only. Exactly the plastic pipes have the greatest advantages and no disadvantages. They are cheaper than metal pipes. It is easier to install and operate plastic. And, most importantly, plastic pipes are more resistant to external conditions and impact thereof – corrosion and fragility. More than 35% (20.4 thousand km) of water supply networks are timeworn, i.e. the deterioration rate is more than 90%. 19.5% (11.3 thousand km) – the deterioration rate is 76–90% and 22.1% (12.8 thousand km) – the deterioration rate is 50-75% (Fig. 1) [Water supply networks of Ukraine: deterioration, service life, unsafe condition].

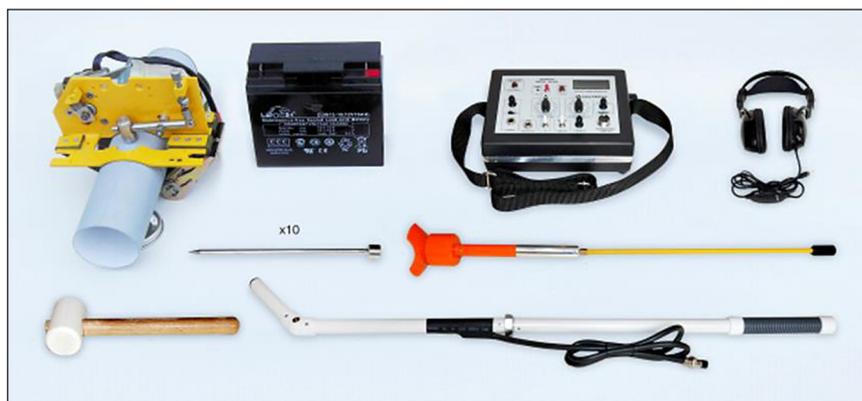
Figure 2. Overview of APGK-015/2 with shock generator

Based on the results of comparing the practical capabilities of these devices, for further research we selected search device APGK-015/2, designed for (Fig. 2):

- search for the route of polyethylene, steel, cast iron, asbestos-cement and ceramic pipelines by acoustic method using a shock generator;
- search of the route of steel pipelines (gas pipelines, water pipelines, heating networks, oil pipelines, product pipelines and power cables) by induction method in passive mode without tone pulse generator;
- search for unauthorized branches of different materials (polyethylene, steel) on water mains, in sewerages by acoustic method;

- search for unauthorized connections to power cables by acoustic method;
- search for leaks in the leak detector mode by the acoustic method in relation to the noise of liquid leaking from the damaged pipeline while the site of the leak may be flooded with water, as well as gas noise in the pipeline;
- search for leakiness in closing of the valves and taps with liquids, air or gas.

Searching for a route of polyethylene and steel pipelines by acoustic method using APGK-015/2 search device is based on the following principle: the acoustic shock generator is installed on the pipeline and fastened by belts. The mechanism of the generator is driven by a small hammer, which effects single shocks on the wall of the pipeline. The pipeline is a resonator, and the sound is transmitted along it over a certain distance. The range of the sound distribution depends on the diameter of the pipe, the material of the pipeline, the presence of liquid, soil density and depth of the pipeline laying. The operator, moving with the acoustic receiver along the route, with the help of the acoustic sensor listens to the sound of the shock on the ground. Above the pipeline the sound of the shock will be the loudest, thus accuracy of the definition of an axis will be +10 cm. The acoustic search method allows to determine the route of a polyethylene or steel pipeline at a distance of several tens to several hundreds meters at a depth of 5–6 m. The range of the propagation of the acoustic signal depends on the diameter of the pipeline. The larger the diameter, the longer distance of the possible search for the pipeline route by the acoustic method. The acoustic sensor is installed across the pipeline with a step of 10–15 cm. Above the route of the pipeline, you can

The frequency of the shock signal propagating along the pipe depends on the diameter of the polyethylene or steel pipe, the presence of liquid in it. Frequency tuning is performed using a block of narrowband filters. The filter unit of APGK-015/2 device has 12 narrowband frequencies of adjustment to the frequency of the shock signal propagating over the pipeline. This function makes its operation more selective and protected from street noise. During the operation of the shock generator, parasitic ground vibrations occur in the form of low-frequency shocks, similar to ones we hear over the pipeline. These shocks propagate through the ground and create an obstacle to the useful signal near the pipeline. There is a so-termed dead zone, where a strong signal of the shock on the ground interferes and covers the useful signal transmitted through the pipeline. 12 rejector filters are designated for tuning away from interfering shocks on the ground and also for protection against street noises and noises of passing cars. The receiver is an amplifier of the acoustic sensor signal and has two types of indication – sound (on headphones) and 10-bit LED indicator.

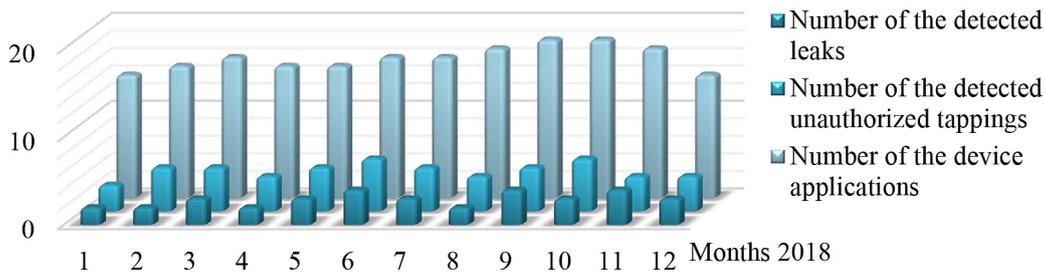
Figure 3. Results of using APGK-015/2 search device by ‘Mykolaivvodokanal’, Communal company, in 2018

the presence of communications in this area by induction method on the magnetic antenna. This is important when excavating, so not to damage other communications. The presence of an electric antenna allows you to determine the communications by the electrical component of the electromagnetic field. In the mode of the leak detector by the acoustic method using receiver APGK-015/2 and the acoustic sensor we listen to above ground noises which arise in a place of the burst of pipelines filled water or other liquids. The high sensitivity of the equipment allows you to hear not only the place of the pipeline burst, but also the movement of water through the pipeline. The accuracy of detecting the location of the leak is 0.5 m. The study of the use of APGK-015/2 device was conducted for two years. The results of the device using in 2018-2019 are shown in Figures 3–4.

During the first half of 2018, 63 hidden emergency leaks and 99 unauthorized tapplings were detected. The using APGK-015/2 device made it possible to establish the main reasons and magnitude of water losses in the city of Mykolayiv: leaks from the water mains (between pumping stations and boost pumps); leaks from city blocks networks, leaks in basements and unauthorized connections; undecount of water consumption by the residents with apartment meters and excessive water consumption by residents without meters.

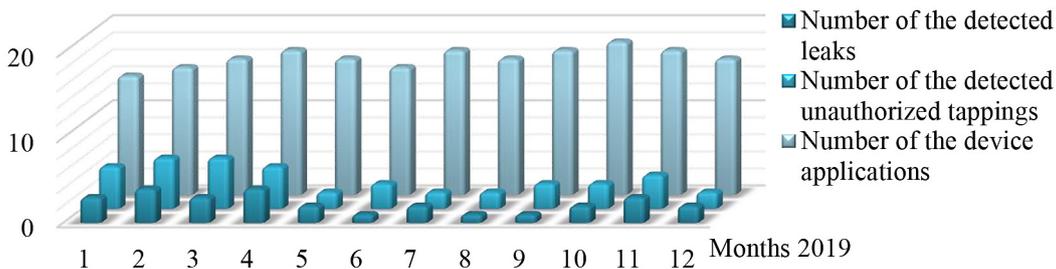
Figure 4. Results of using APGK-015/2 search device by ‘Mykolaivvodokanal’, Communal company, in 2019
